Technical Info

Thermomixer comfort 5355 000.011

Thermomixer R 5355 000.020

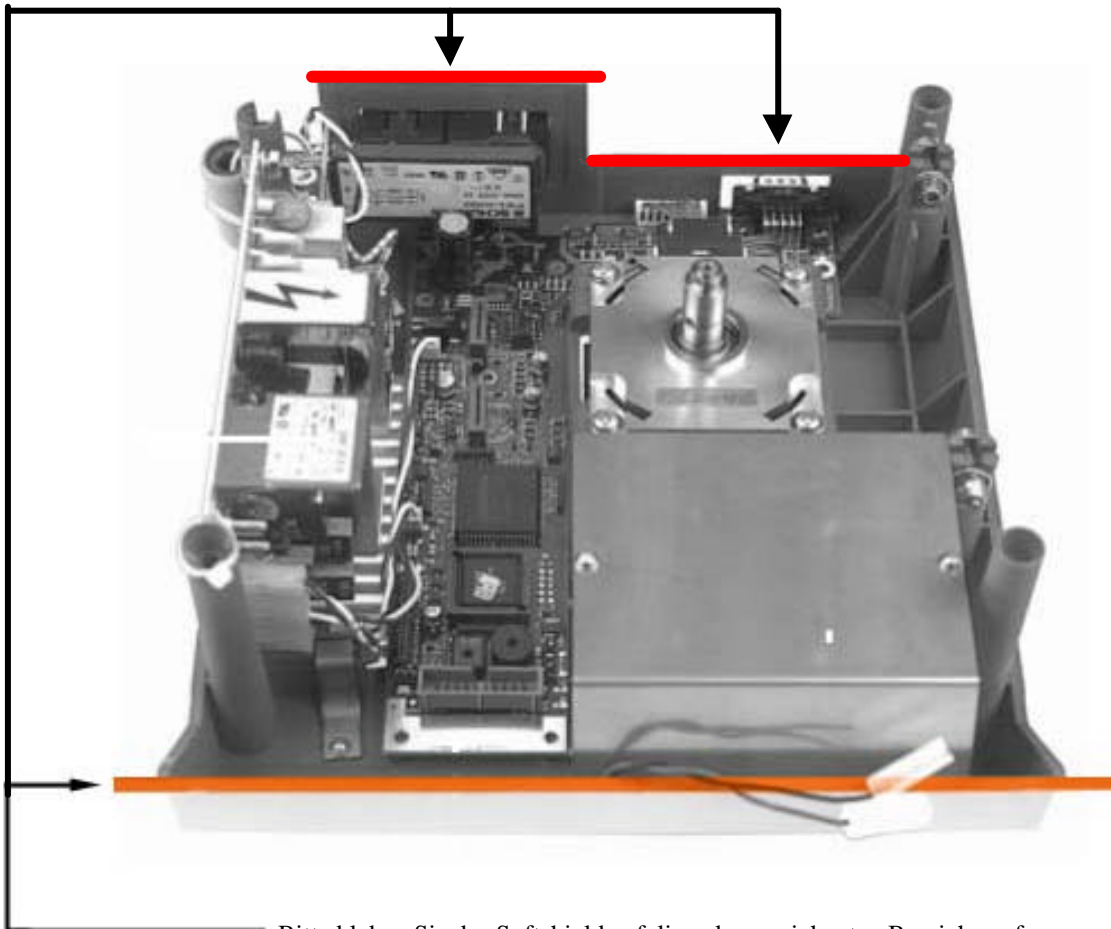
Bitte kleben Sie das Softshield auf die gekennzeichneten Bereiche auf.
Please glue the soft shield to the marked areas.

(Order No. 0011 205.208, soft shield, length = 1 m.) The disassembly of the upper part of the housing is described in the service manual for thermomixer 5355 900.055. The way to glue the soft shield is described on the following page of this PACT.
