Thermomixer comfort 5355 000.011
Thermomixer R 5355 000.020

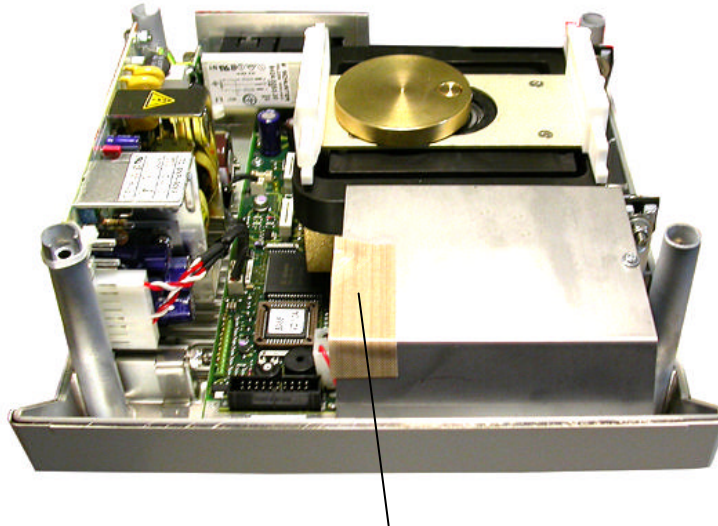
This foil cable (green) is positioned on the metallic ventilator cover and is subject to vibrations during the mixing operation. These vibrations sometimes damage the insulation at one place to such an extent that there is sporadic contact with the ground.

This ground connection is recognized by the device as a keystroke, because the damaged cable is responsible for the temperature keys. The temperature is thereby increased by 1°C each time the cable comes into contact with the metal.

Please apply the insulation strip here.

This can be remedied by applying an adhesive insulation strip to the ventilator cover (see photo).

We ask you to replace this insulation strip and to check the keyboard cable for damage after all repairs or maintenance.

The **order number** for the insulation strip is **5355 862.005**
